Sulphur Bank Mercury Mine Superfund Site

June 5, 2019

Presentation Overview

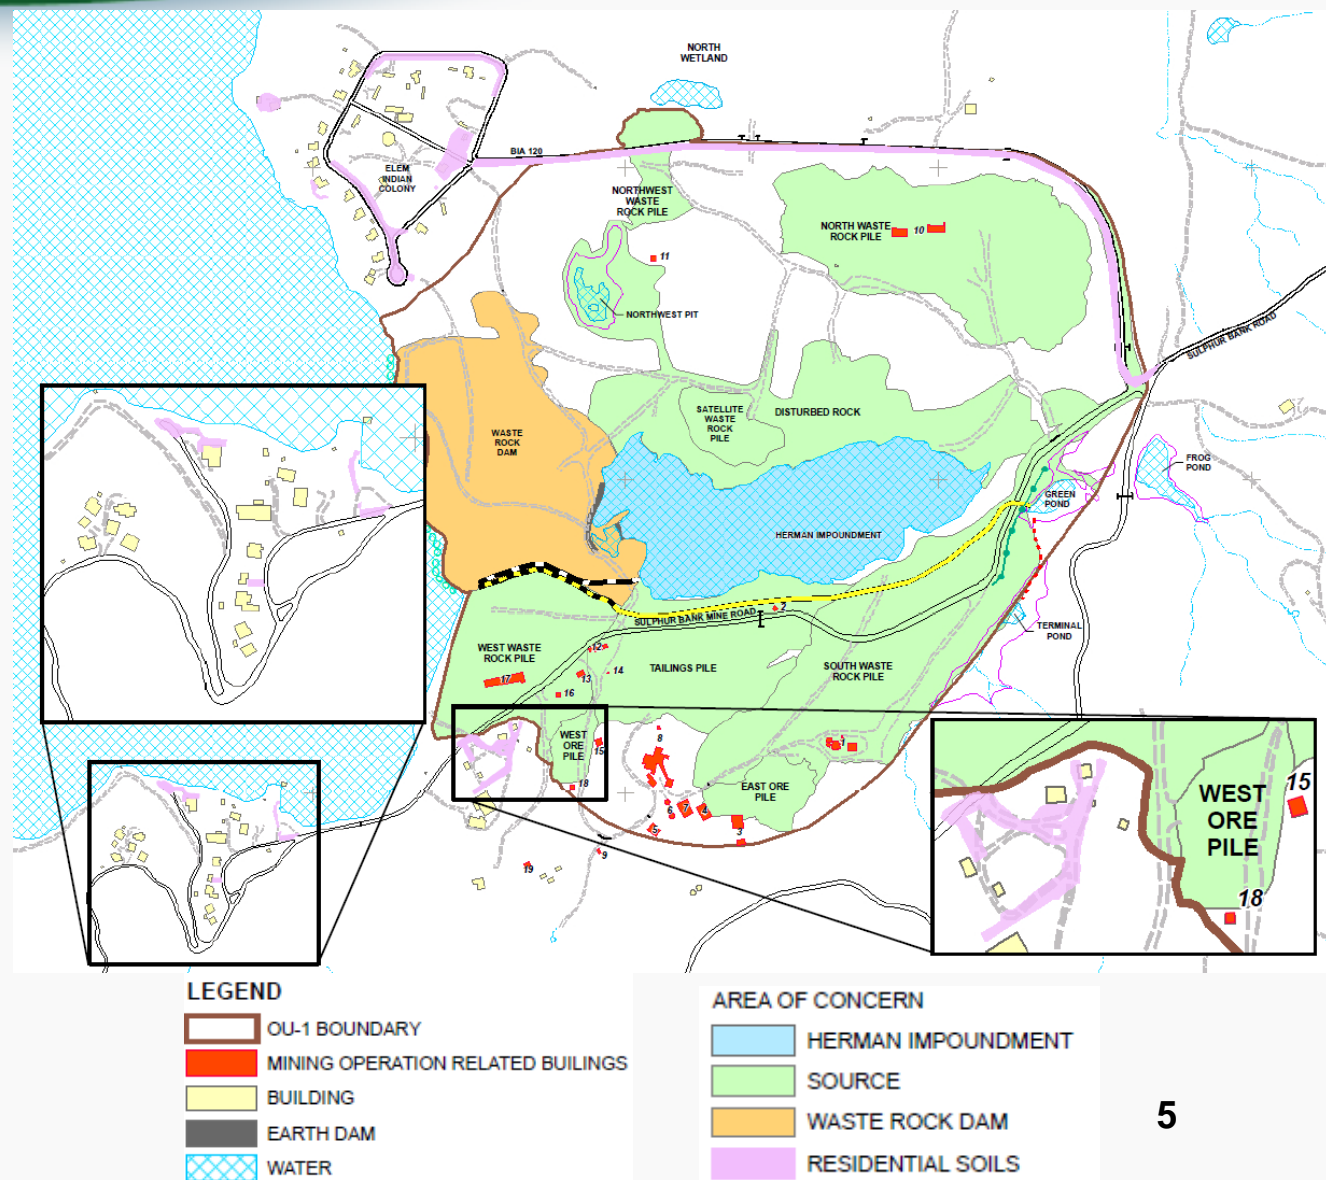
Major Mine Site Features

Source Areas

- Waste Rock Piles
- Ores Piles
- Tailings Pile
- Disturbed and Native Rock
- Northwest Pit
- Mining Facilities/Buildings

Herman Impoundment (HI)

Waste Rock Dam (WRD)

Off-Site Residential Soils

- Elem Indian Colony
- BIA 120
- Sulphur Bank Mine Road neighborhood

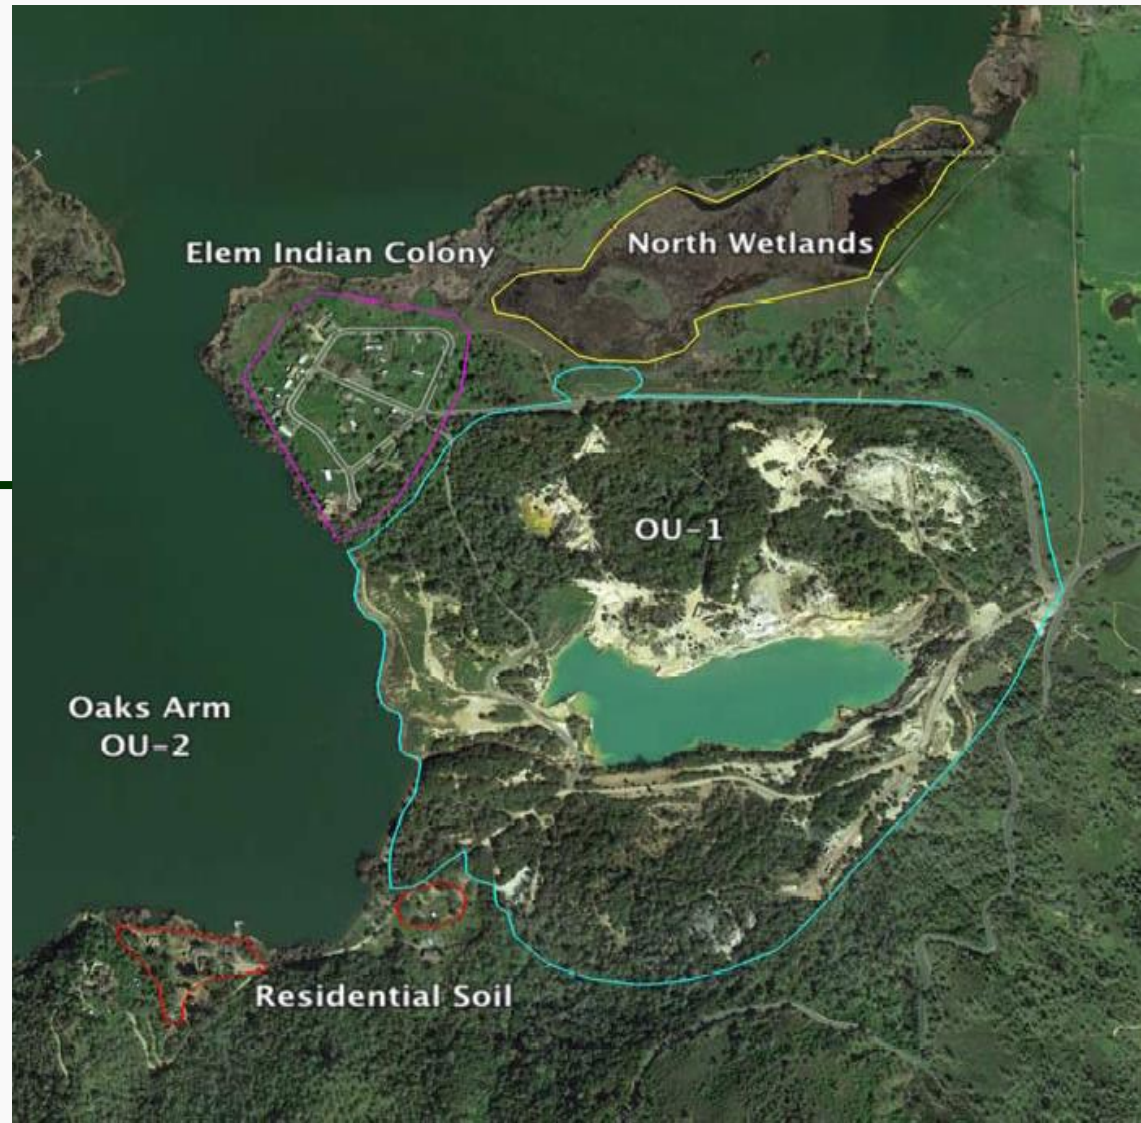
Site Overview

Terrestrial Mine Site and Residential Soils

Operable Unit 1

Lake Sediments and North Wetlands

Operable Unit 2

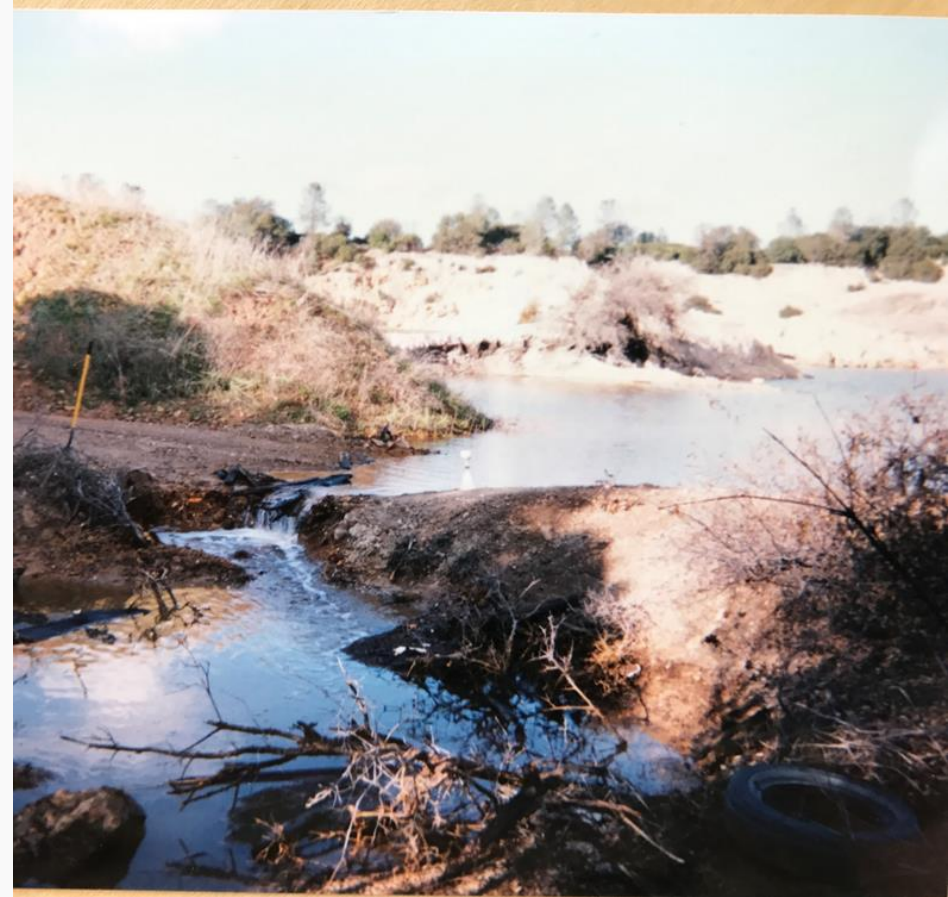
SBMM Impacts on Clear Lake Water Quality

4 pathways SBMM contaminants to enter Clear Lake

1. Direct placement during mining operations
2. Erosion of mine waste, usually stormwater or direct sloughing of unstable areas
3. Overflow of Herman Impoundment
4. Mine-impacted groundwater discharges into the lake, primarily HI water moving through the WRD

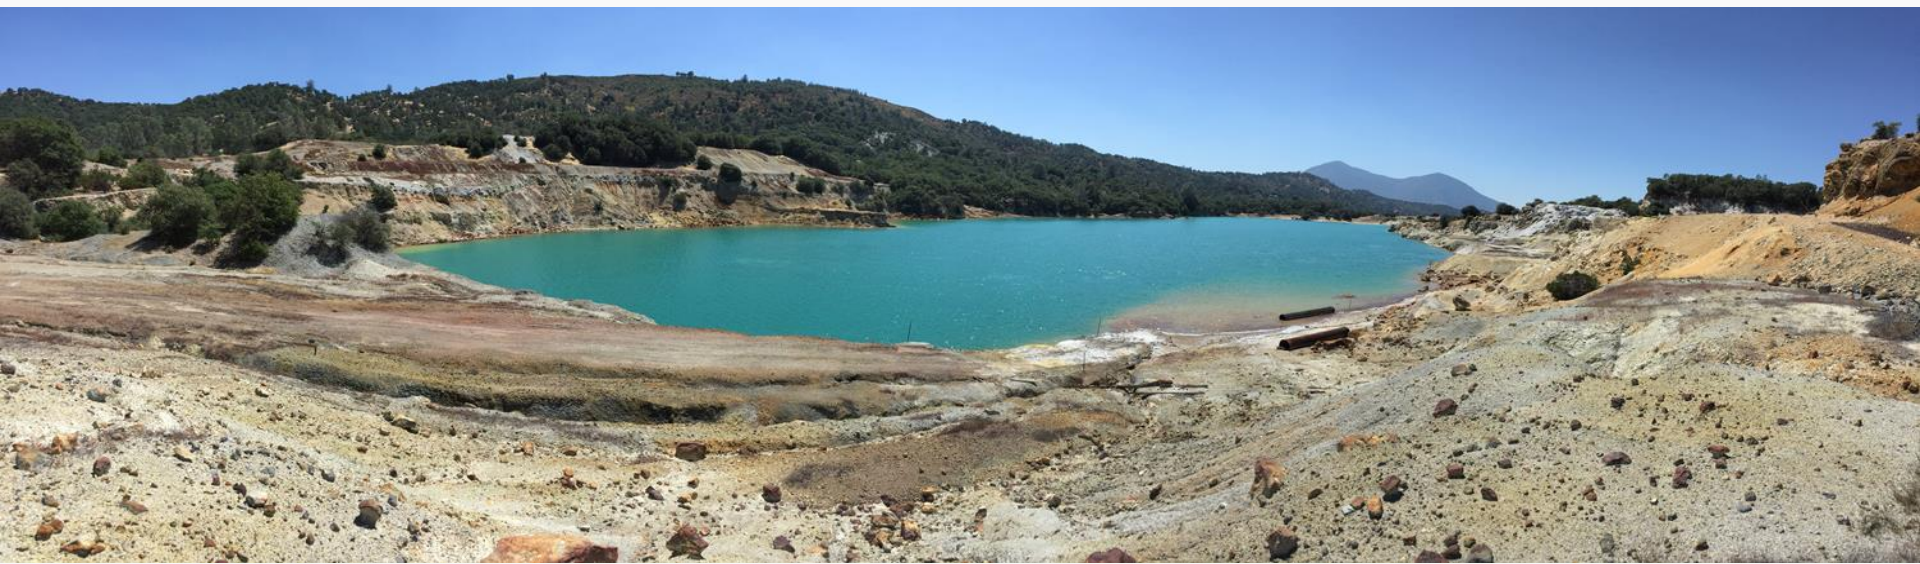
Revised Site Understanding

Changes in Herman Impoundment water quality

- Stormwater divisions and drought led to improved water quality in Herman Impoundment – pH from around 3 to nearly 5
- Capping the exposed mine waste at the site would further:
 - Reduce acid rock drainage
 - Reduce hydraulic head pushing water through WRD
 - Reduce contaminant loading into Clear Lake
- Once waste is capped, HI water chemistry modeled to move toward background groundwater quality
